PLUS BERHAD

OBSERVATIONS AND ANALYSIS ON RAINFALL INDUCED SLOPE FAILURES FOR JELAPANG AND GUA TEMPURUNG AREA USING G.I.S.

MAY 2015

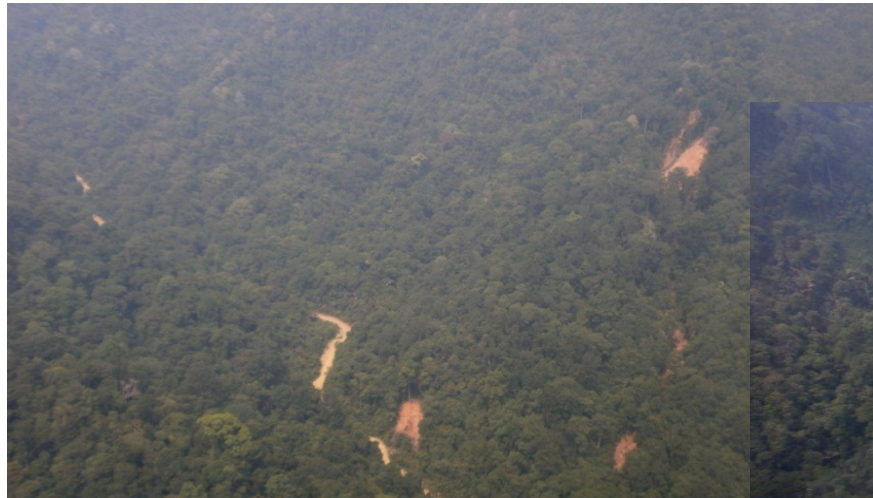
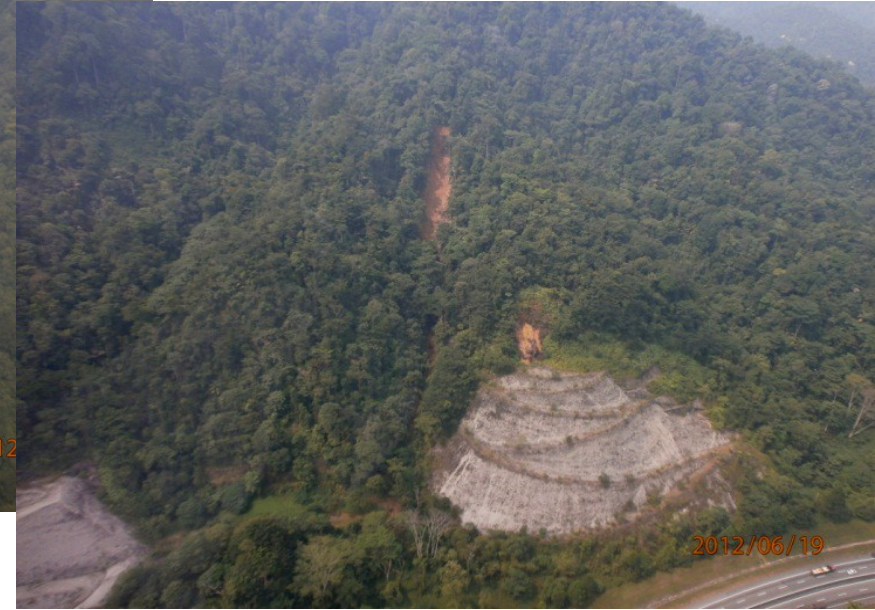
CASE STUDY – GUA TEMPURUNG AREA (MULTIPLE SLOPE FAILURES)

Slope failure at Gua Tempurung area.

Seven (7) new failures scars beyond ROW observed during aerial inspection dated 18 June 2012

- The slope failures occurred at steep natural slope (estimated gradient more than 35°)
- Shallow surface failures (estimated between 2 to 3 m deep and wide between 10m to 20m – failures occurs within the root zone of the hill-side slopes)
- The residual soil for the upper region of the natural hill slopes is shallow, between 1m to 3m depth (observed via helicopter visual survey)
- The exposed soil ranges from yellow to reddish soil (normal for granitic residual soil)

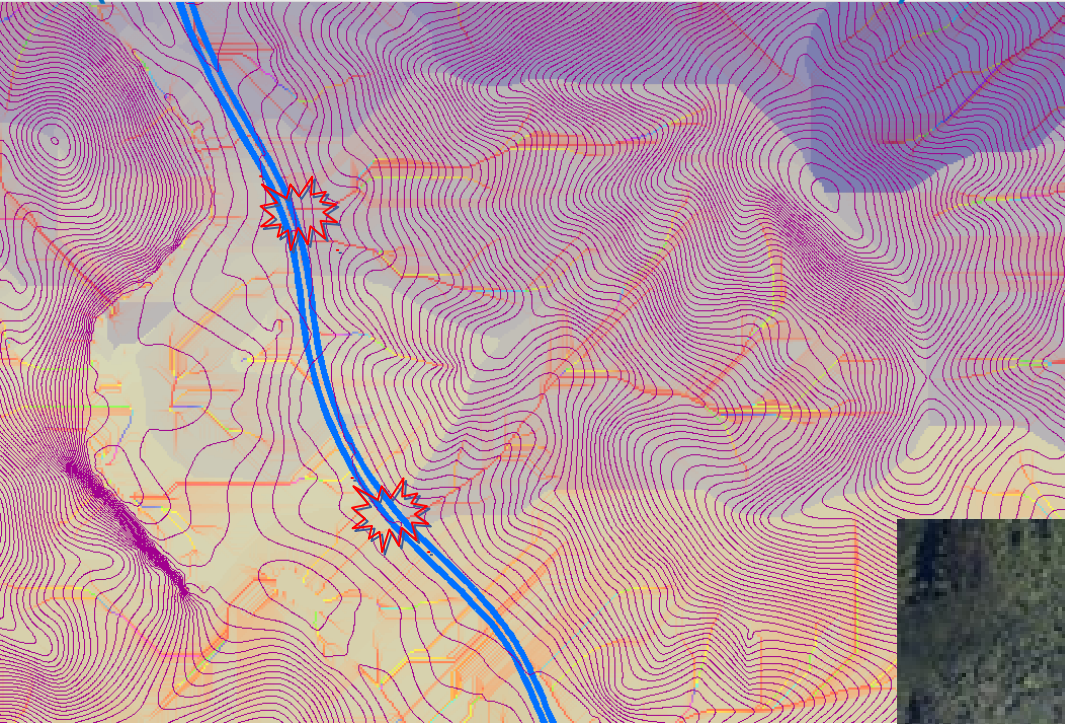
CASE STUDY – GUA TEMPURUNG AREA (CATCHMENTS - HYDROGEOLOGY)

Basin:

- Catchment
- Funnel shape
- Small outlet
- Impact point
