PLUS BERHAD

OBSERVATIONS AND ANALYSIS ON RAINFALL INDUCED SLOPE FAILURES FOR JELAPANG AND GUA TEMPURUNG AREA USING G.I.S.

MAY 2015

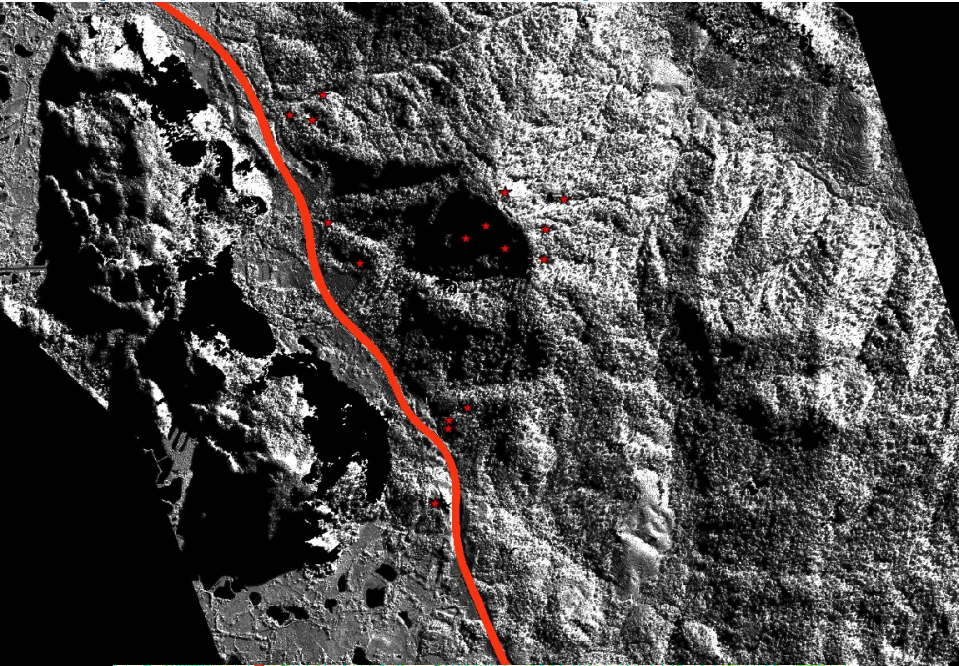
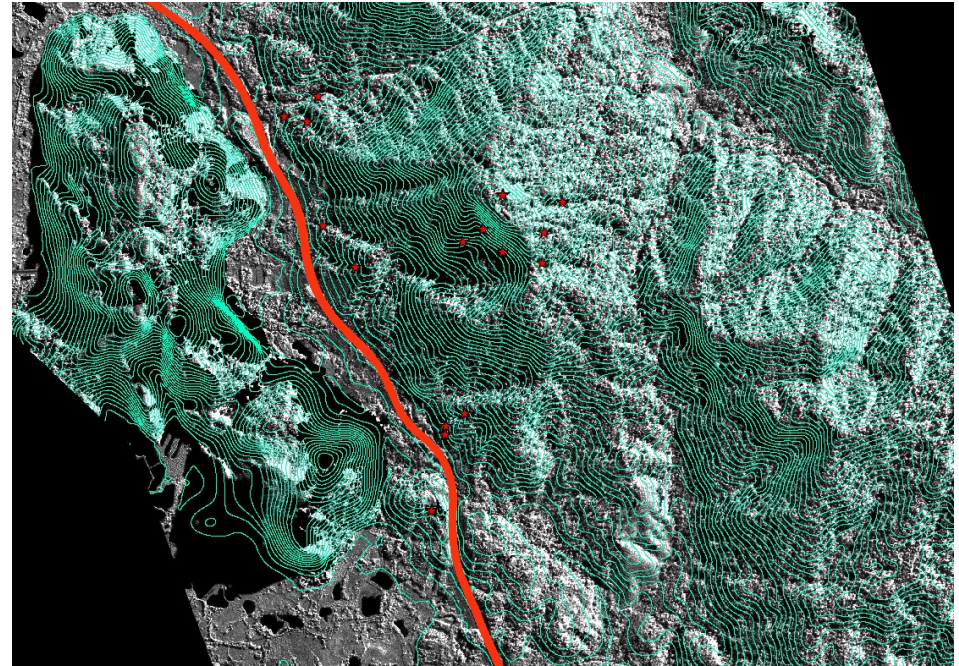
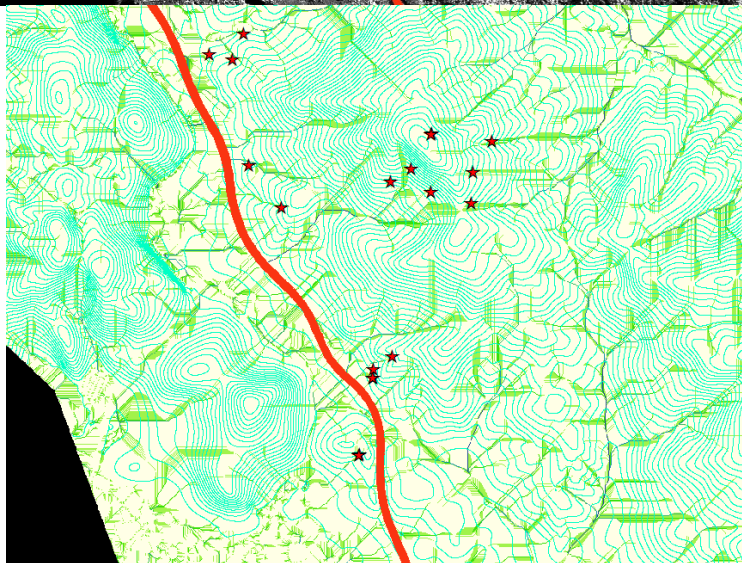
CASE STUDY – GUA TEMPURUNG AREA (SURFACE ANALYSIS)

- DTM and mapping
- Surface analysis
- Hydrology Analysis
 - Flow direction
 - Flow accumulation
 - Stream order

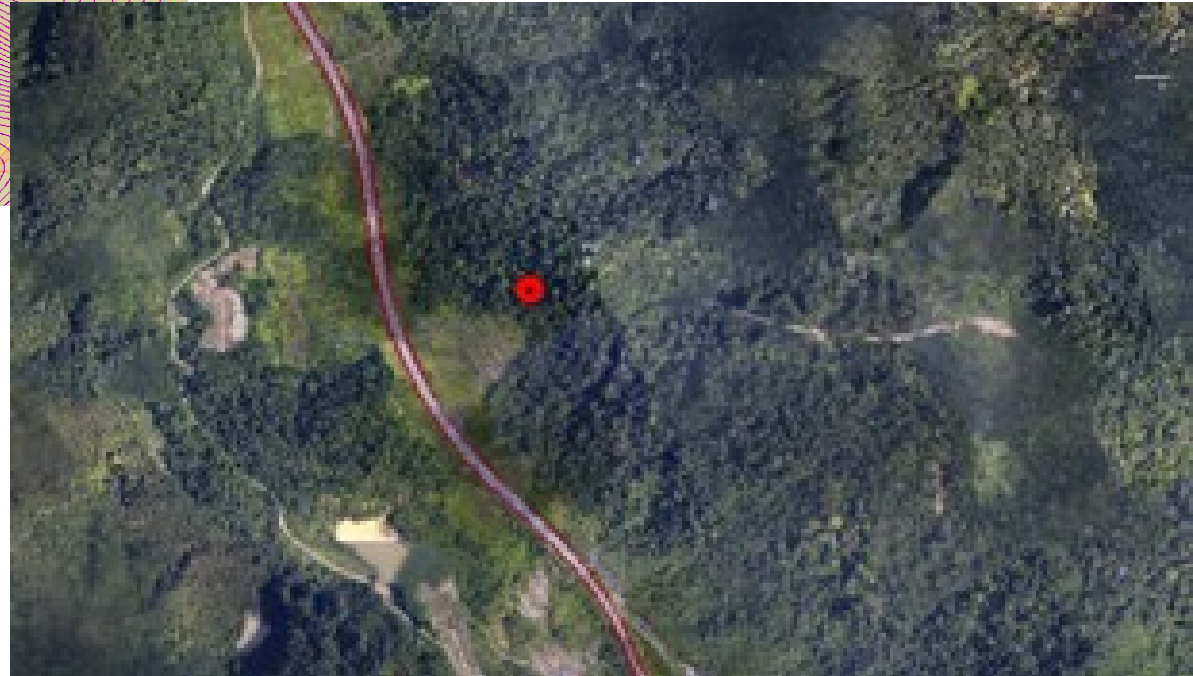
CASE STUDY – GUA TEMPURUNG AREA (CATCHMENTS - HYDROGEOLOGY)

Basin:

- Catchment
- Funnel shape
- Small outlet
- Impact point
